FISHERMAN'S JETTY
STRATEGIC WORKSHOP
9 June 2021

Port Pirie
 Regional Council

ANNEXURE A
Fisherman's Jetty – Locality Plan and Images

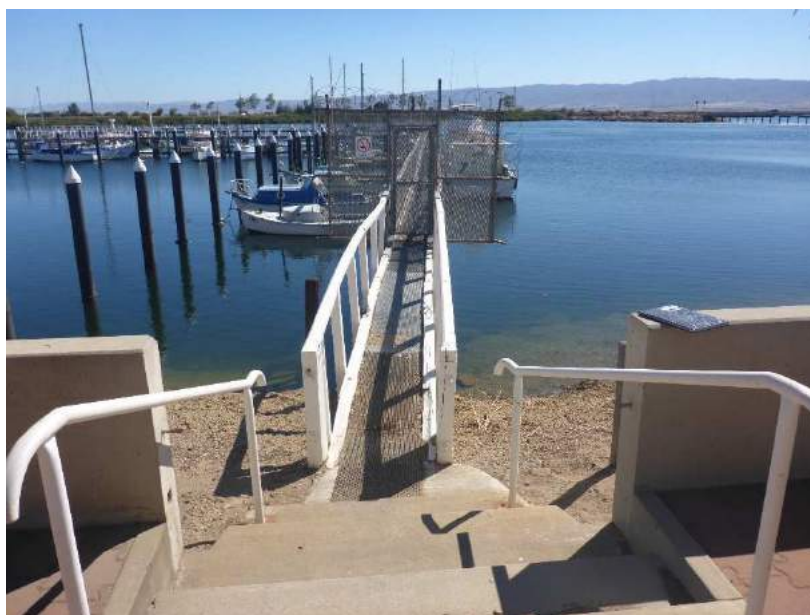
The approach to Fisherman’s Jetty is via non standard concrete stairs with steel handrails. These stairs would be difficult for disabled people accessing the jetty and for people wanting to load stores and fuel onto moored craft. Consideration should be made to providing ramp access to the jetty.

Photo 2 – Jetty approach with non standard concrete stairs

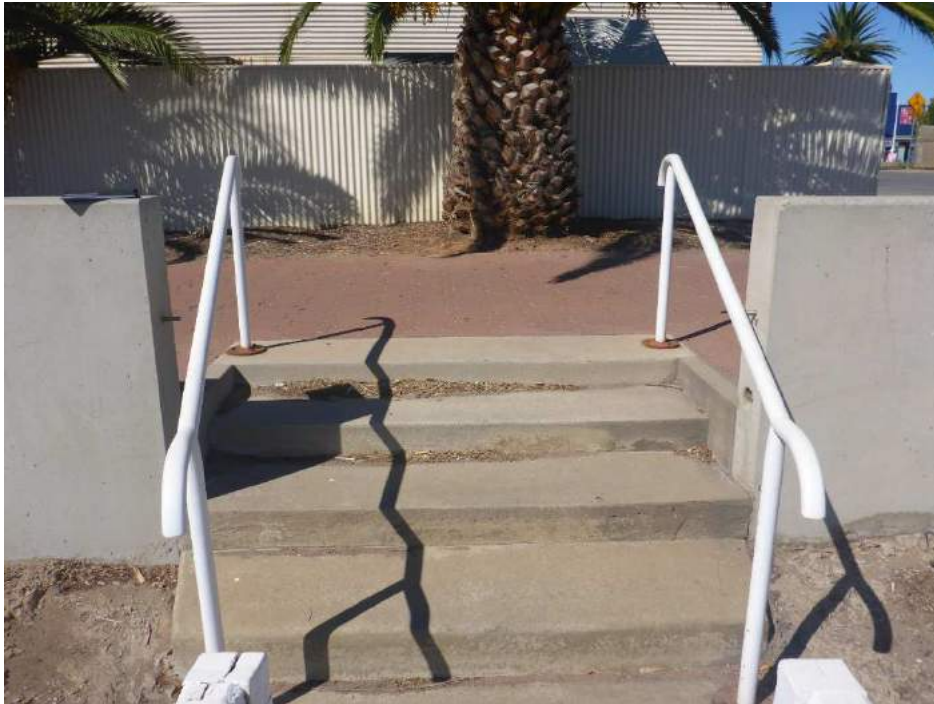
Photo 3 – Concrete stairs with room for ramp access to be provided

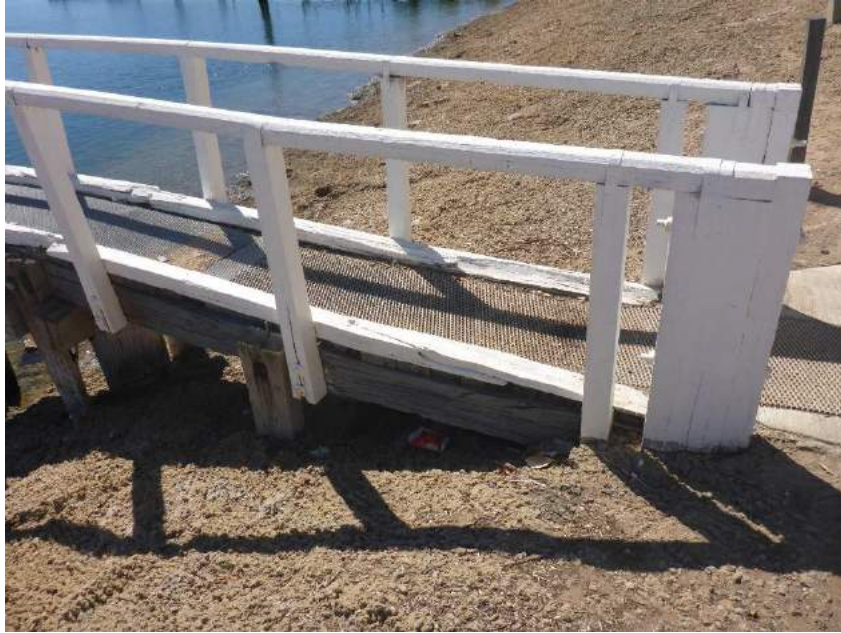
The two girders at the jetty abutment are supported on a timber corbel and appear to be in fair condition. The larger vertical timbers at the end of the handrail also are connected to the girders and these appear in reasonably sound condition with minimal movement.

Photo 4 – Jetty abutment with large vertical timbers at the end of the handrail

The underside of the abutment should also be inspected for any evidence of termite activity. Termite damage to abutments is a common problem for jetties.

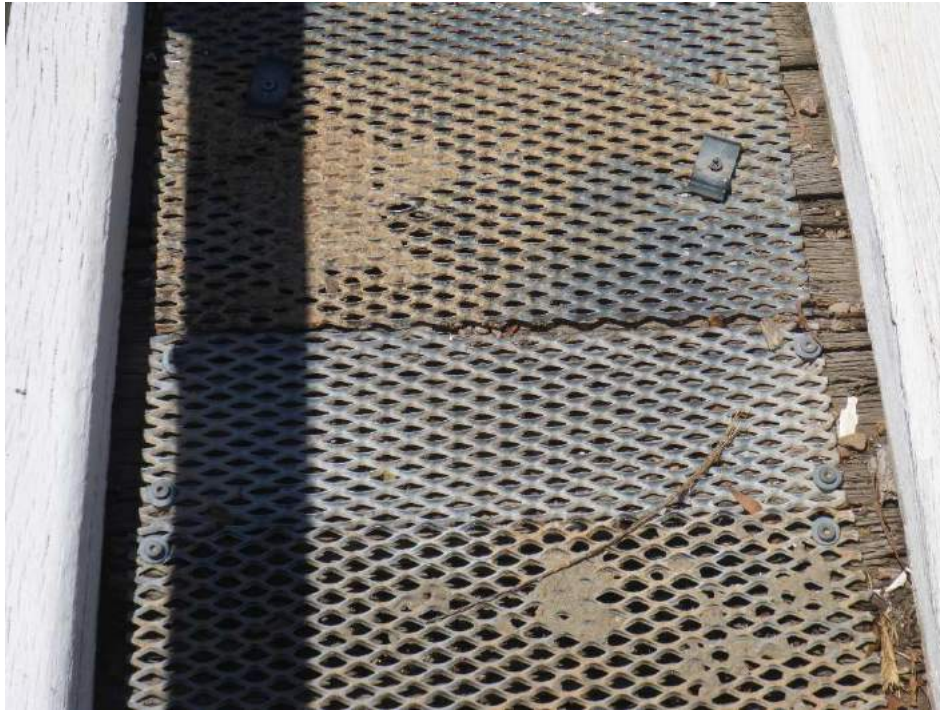
Some of the deck planks are quite weathered and loose resulting in the connections to the grating becoming loose. If these connections cannot be tightened, the planks should be replaced with sound timber planks.

Photo 6 – Weathered and loose timber planks

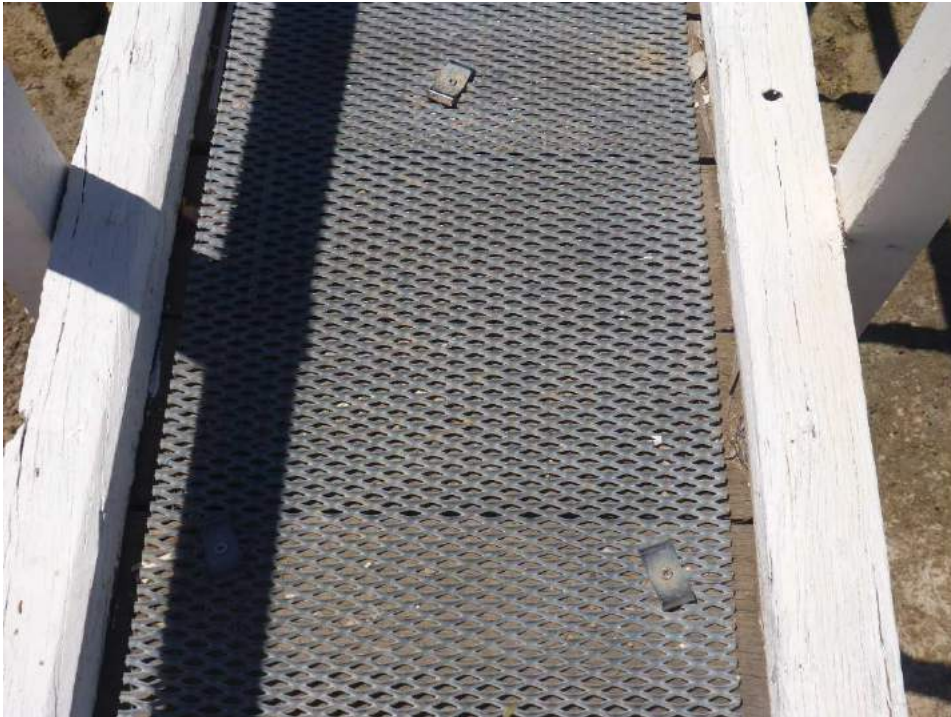
The steel grating is connected to the timber planks over most of the jetty length with raised steel brackets. These brackets are generally located on both sides and centrally on the grating. Many of the brackets are loose and these should be tightened with the central brackets removed and replaced by edge brackets.

Photo 7 – Typical connections of steel grating to timber planks

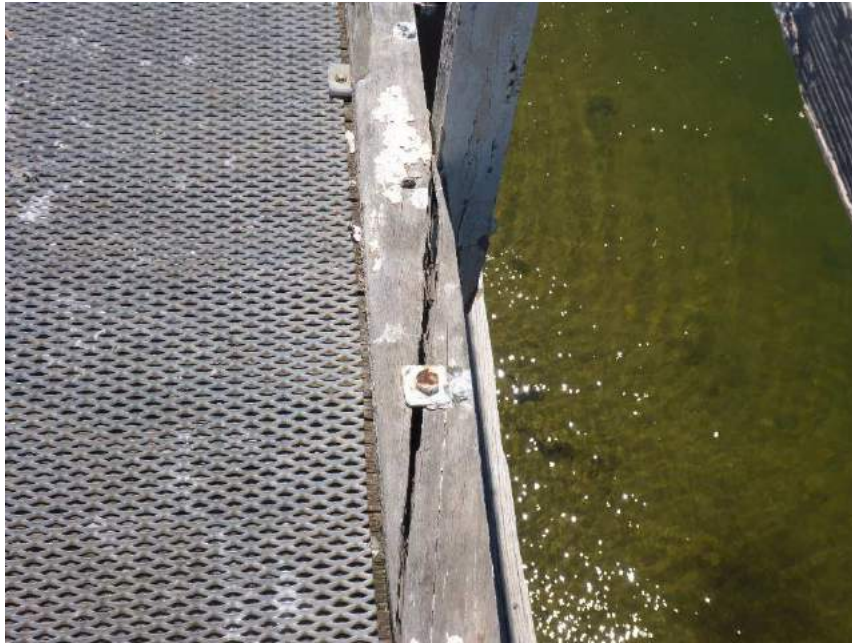
There are sections of the kickboard that are badly deteriorated and cracked. Some of these sections can be repaired whilst others require replacement.

Photo 8 – Section of badly cracked kickboard

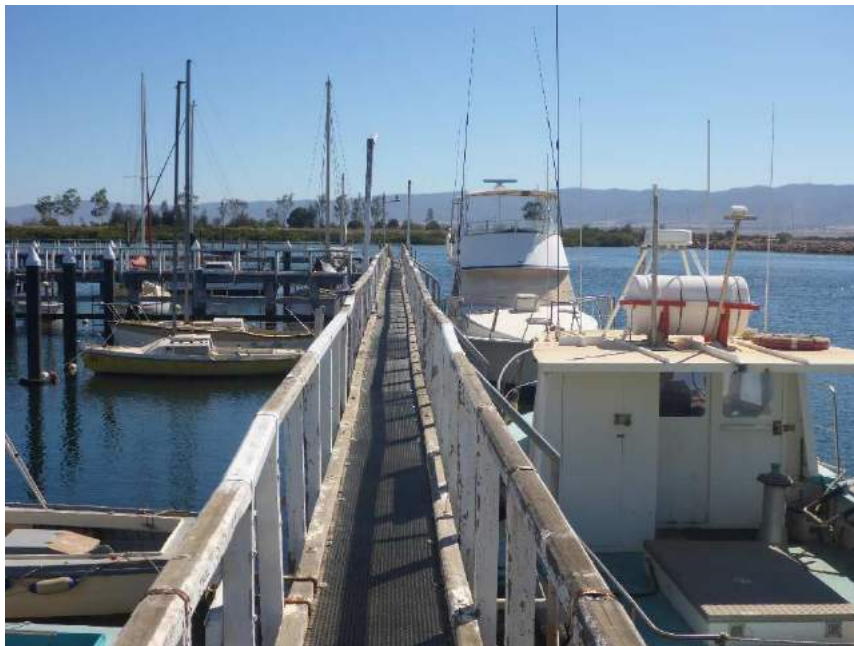
The handrails on both sides of the jetty deck comprise timber posts at 1100 mm to 1300 mm spacing with a timber top rail. The height to the top of the handrail varies from 850 mm to 900 mm. There are sections of the handrails that have loose posts and the overall alignment is quite poor.

Photo 9 – Handrails both sides with poor shape and alignment

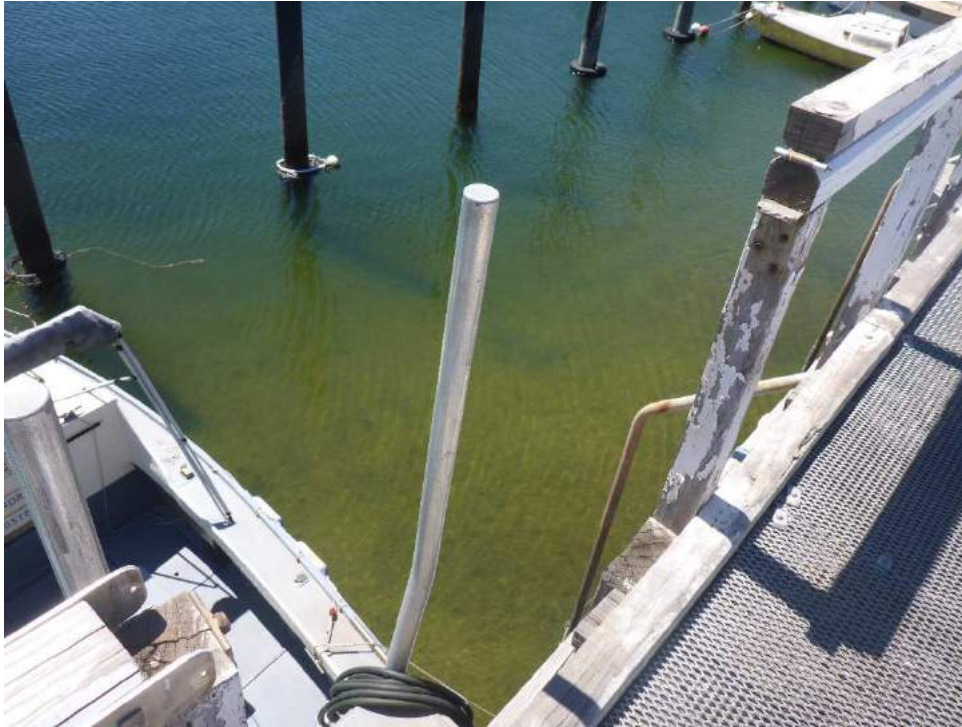
A further concern with the stability of the handrails is that adjacent to most moorings, where there is an access ladder up to the jetty deck, a section of the handrail has been cut, hinges installed and a gate created. These gateways improve the safety for people using the access ladders but the adjacent posts should have the connections strengthened.

Photo 10 – Section of handrailing cut and hinged to form gateway for ladder access

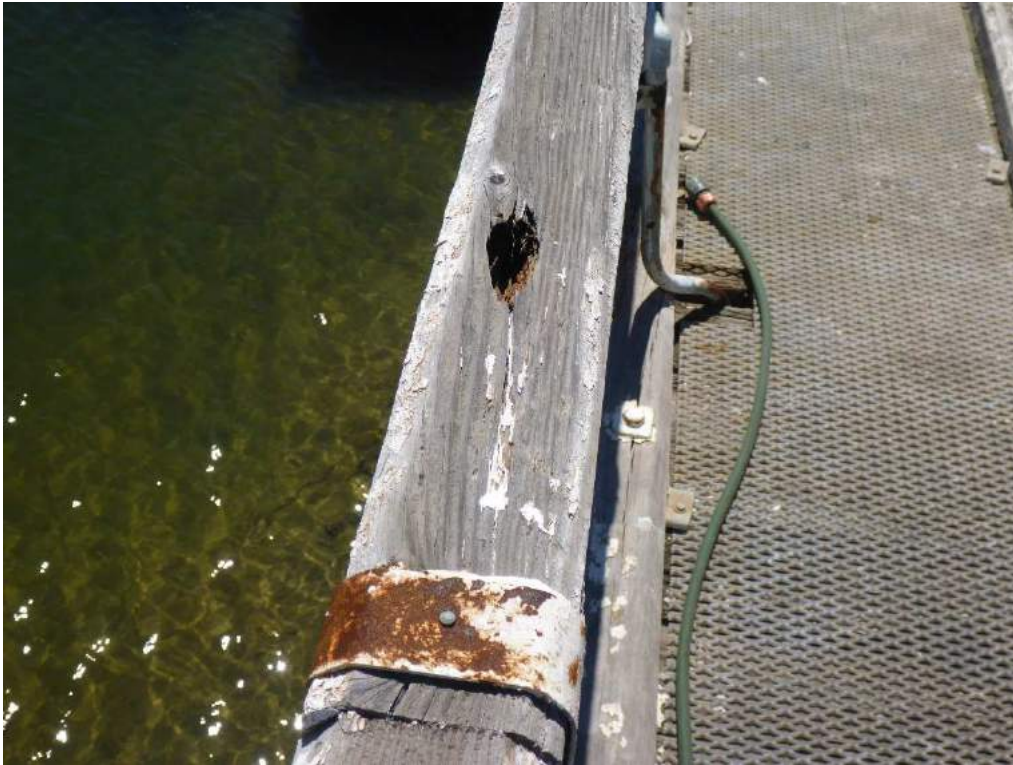
A further concern with the handrailing is the deterioration of some sections of the top rail. Some of these will require replacement, whilst others will be able to be patched and painted.

Photo 11 – Section of rotted top rail and rusted steel strap

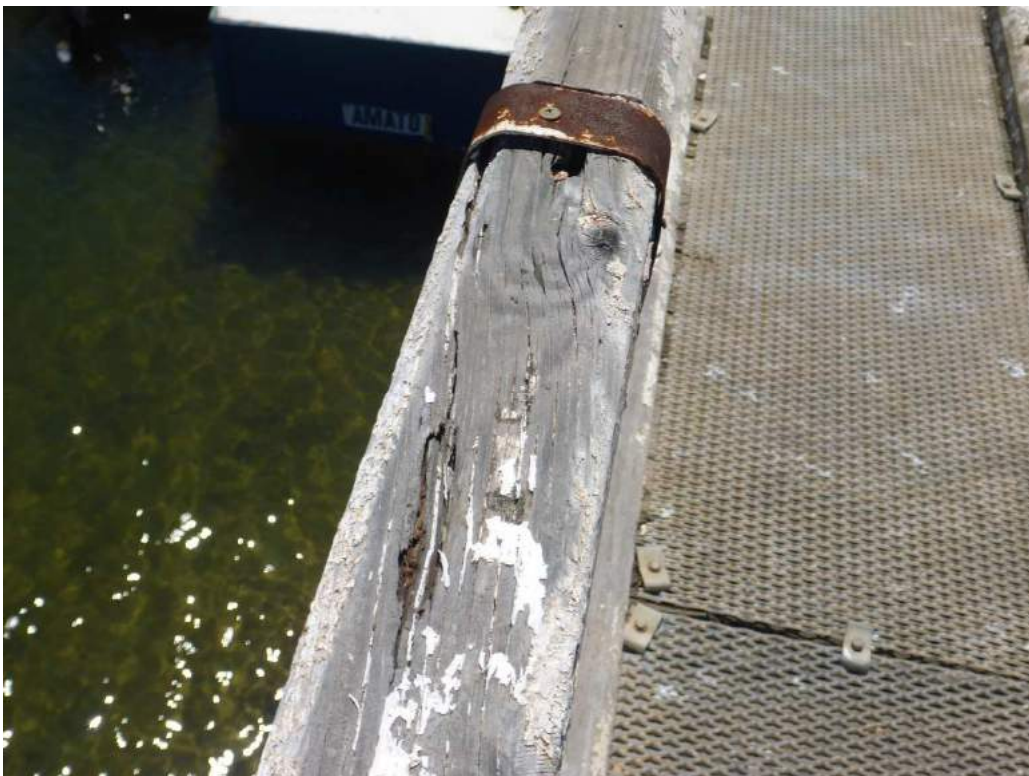
Photo 12 – Section of cracked and rotted top rail with rusted steel strap

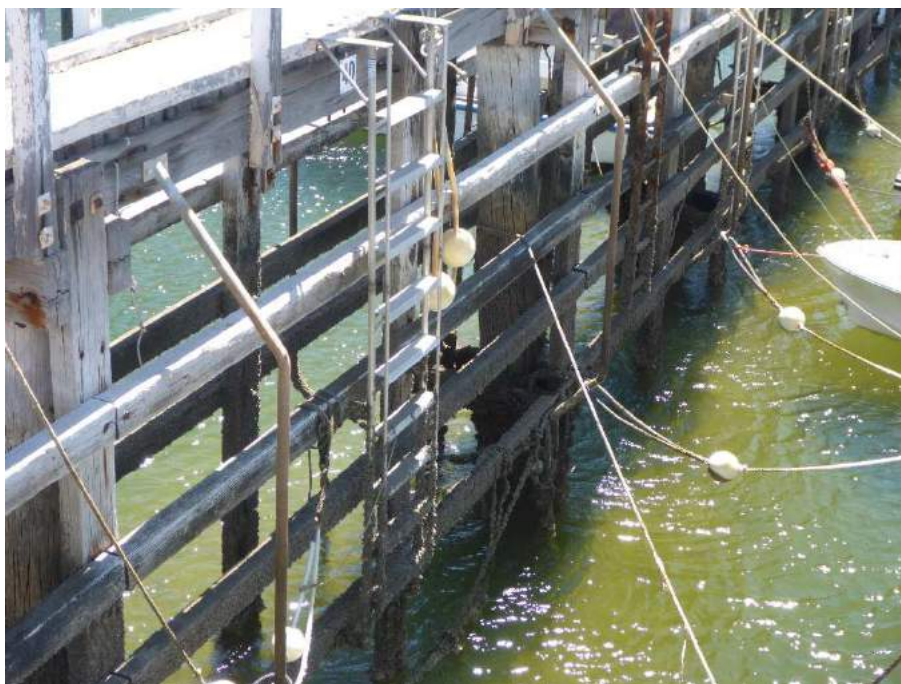
The inspection occurred during a relatively low tide and all of the ladders bottom rung were above water level. In addition none of the ladders had buffer rails provided. Of further concern was that many of the ladders terminated at jetty deck level making access on and off the jetty a relatively dangerous manoeuvre.

Photo 13 – Access ladders above water level at low tide

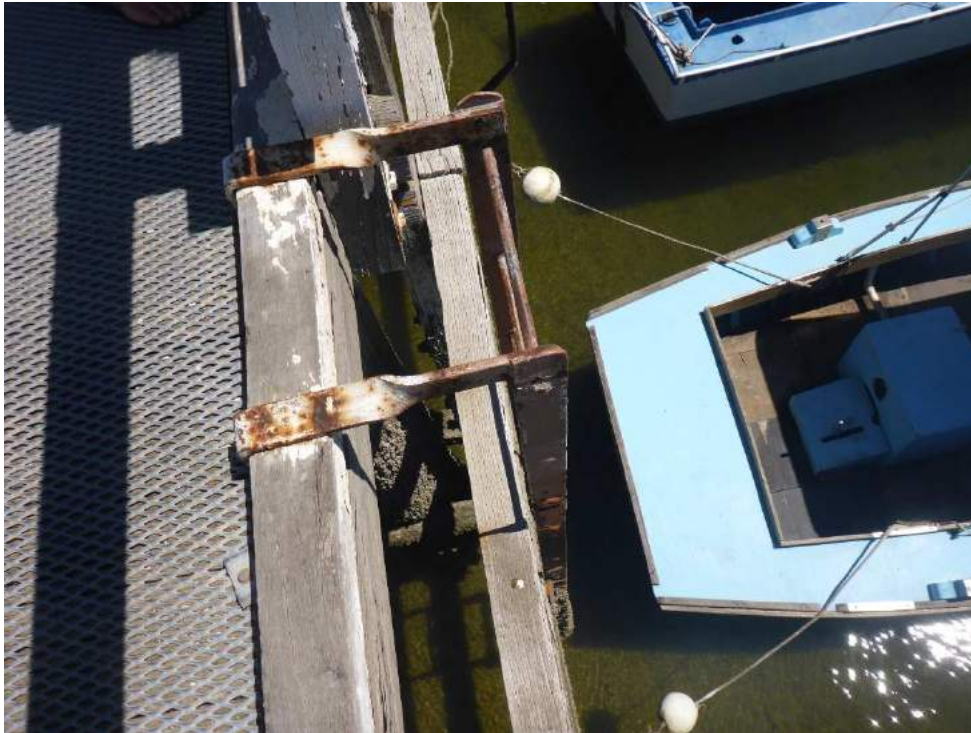
Photo 14 - Access ladder terminating at jetty deck level

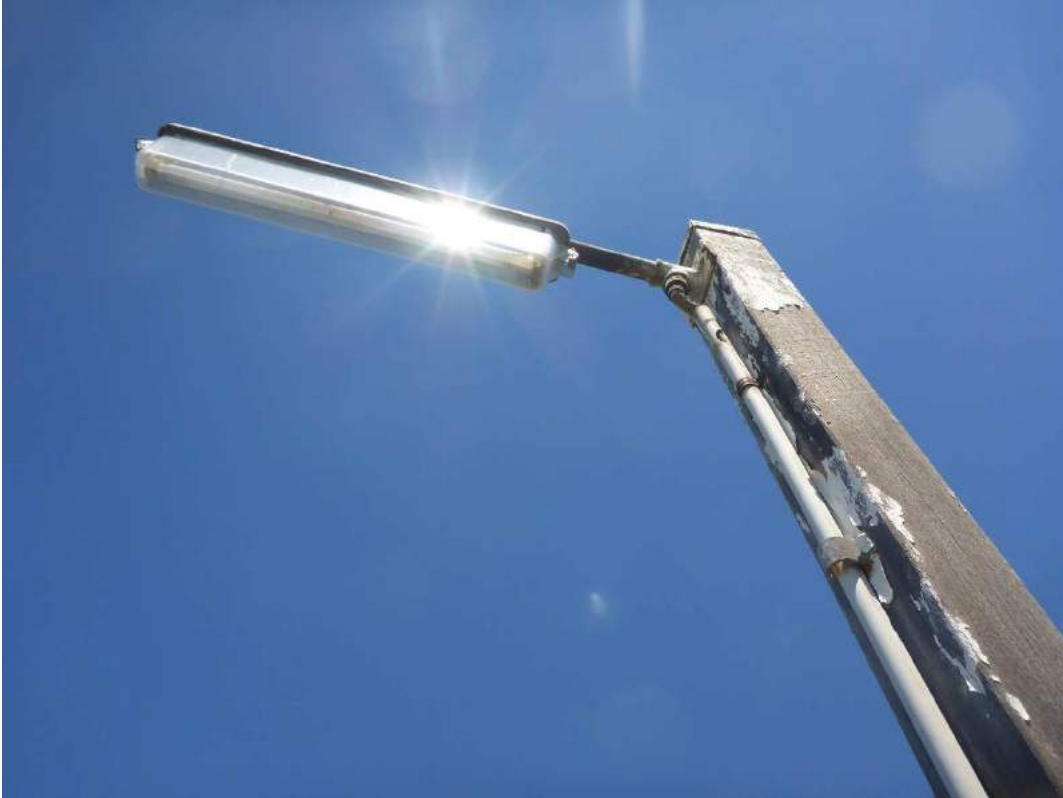
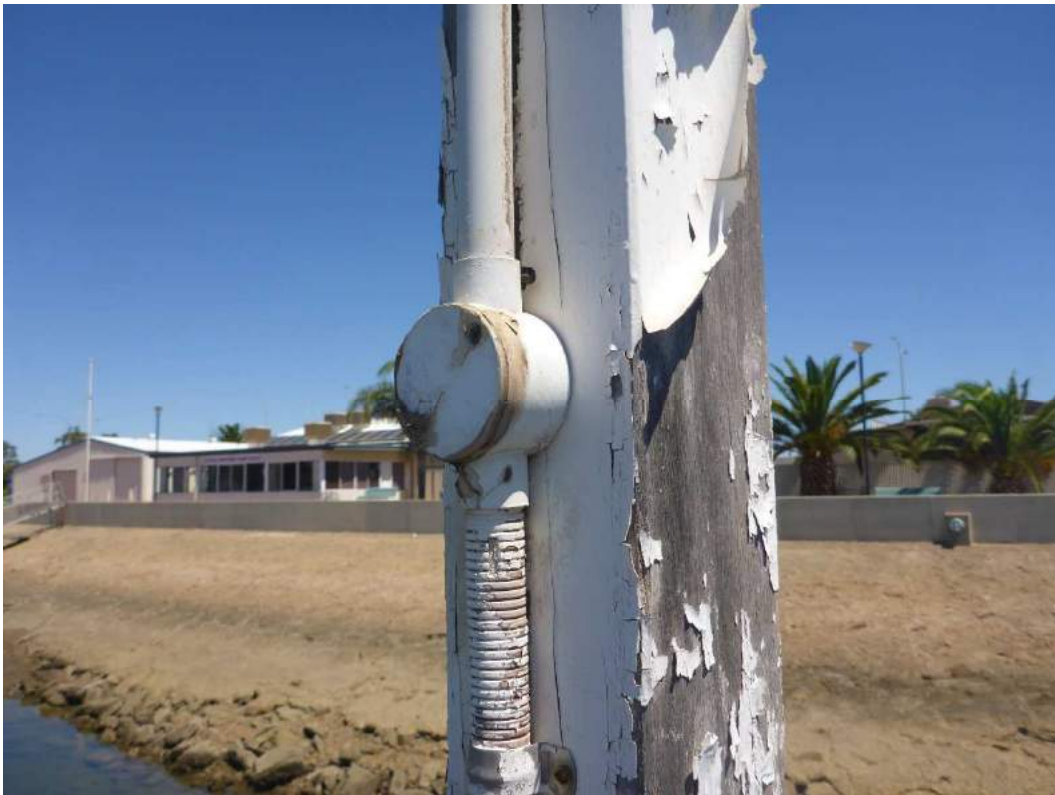
Photo 15 – Typical light pole and single light

Photo 16 – Typical light pole installation

As the standard of the electrical installation is not known, it is recommended that an electrician inspects the electrical installation to ensure that it is complying to Australian Standards. Then due to the aggressive environment, regular inspections should be undertaken of support brackets, conduits, cables and fittings to ensure they remain in good condition.

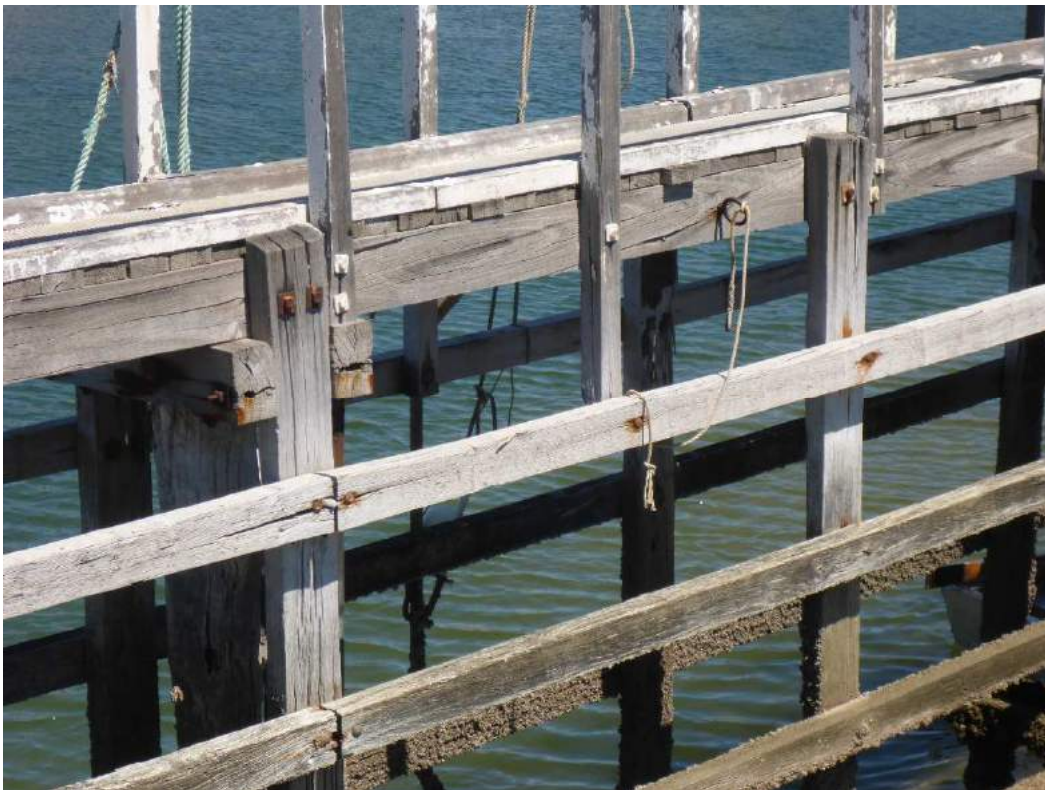
Most of the girders and crossheads are in a state of deterioration but remain serviceable. They are generally cracked along part of their length with splits in the ends.

The connection bolts are heavily corroded and some were loose. All bolts should be checked and loose bolts tightened.

Photo 17 – Timber girders with minor longitudinal cracking and crossheads with split ends

As part of Council's inspection procedure an inspection of the timber girders and crossheads should be undertaken as a minimum on a yearly basis.

| • Replace heavily corroded bolts and tighten bolts that can be tightened in connections to timber girders and crossheads | \$21,000 |

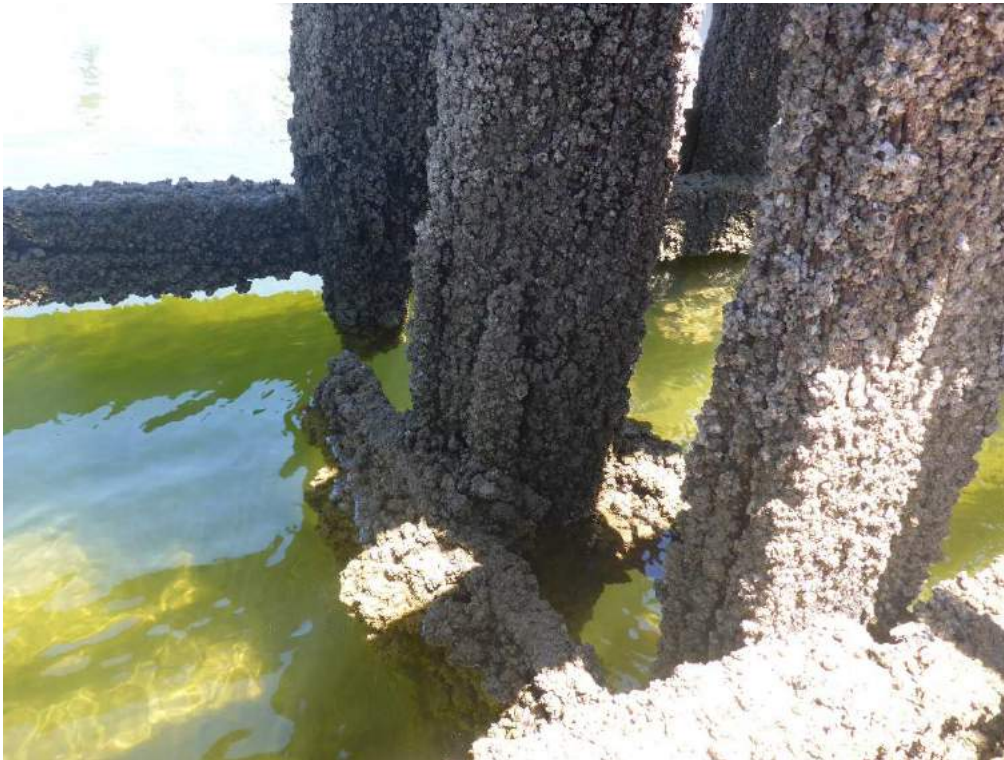
There are timber braces along the majority of the length of the structure. The braces range in condition from serviceable condition to badly deteriorated to missing with only the bolts remaining. Whilst it is not critical to have all bracing in place along the structure, sufficient bracing should be present to minimise movement of the jetty. On this basis, there will be a need to replace many of the missing and deteriorated timber braces.

Photo 18 – Badly deteriorated timber bracing

| • Replacement of missing bracing and bracing with less than 30% cross sectional area remaining with equivalent sized timber members (important to be year 2) | \$41,000 |

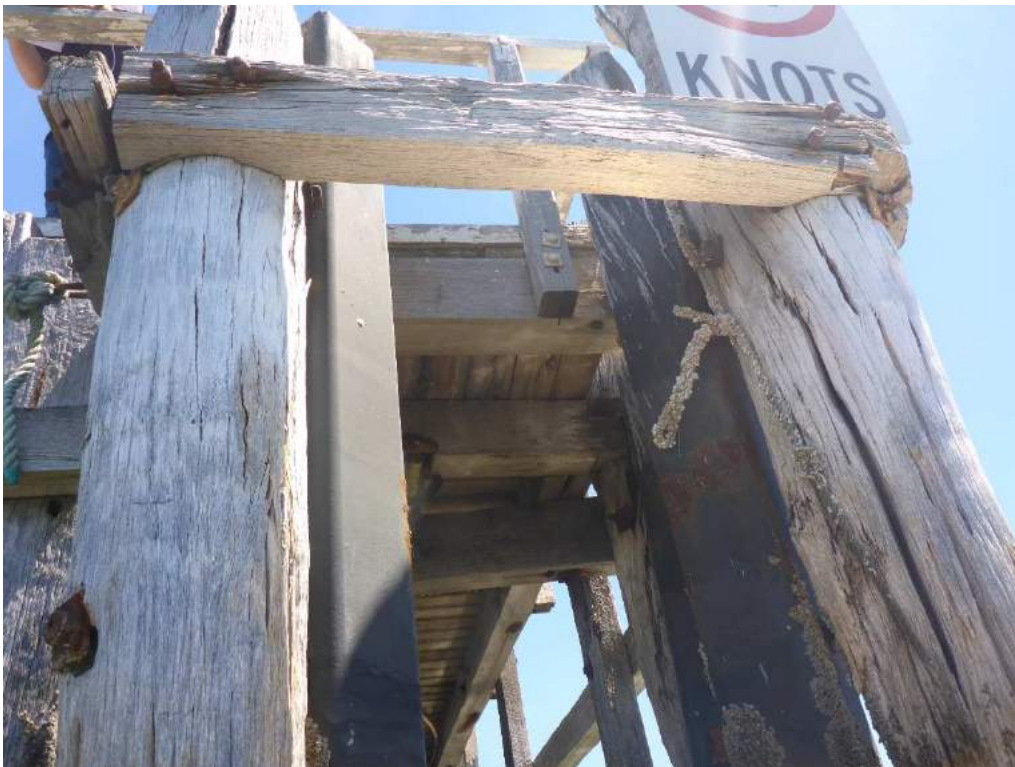
These steel piles range from fair condition to quite heavily corroded and require cleaning and protective coating being applied. All of the steel piles appear to be providing adequate stability to the jetty structure.

Photo 21 – Two steel piles at the end of the main walkway showing some corrosion

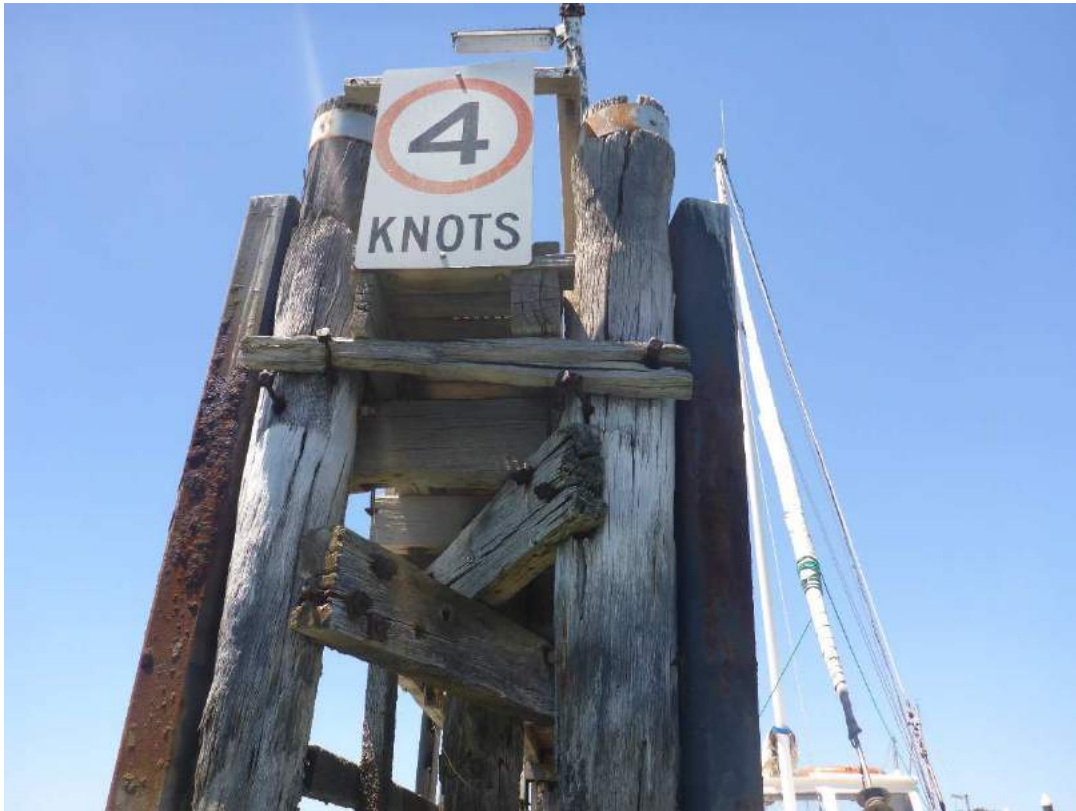
Photo 22 – Two steel piles at the end of the outer walkway with quite heavy corrosion

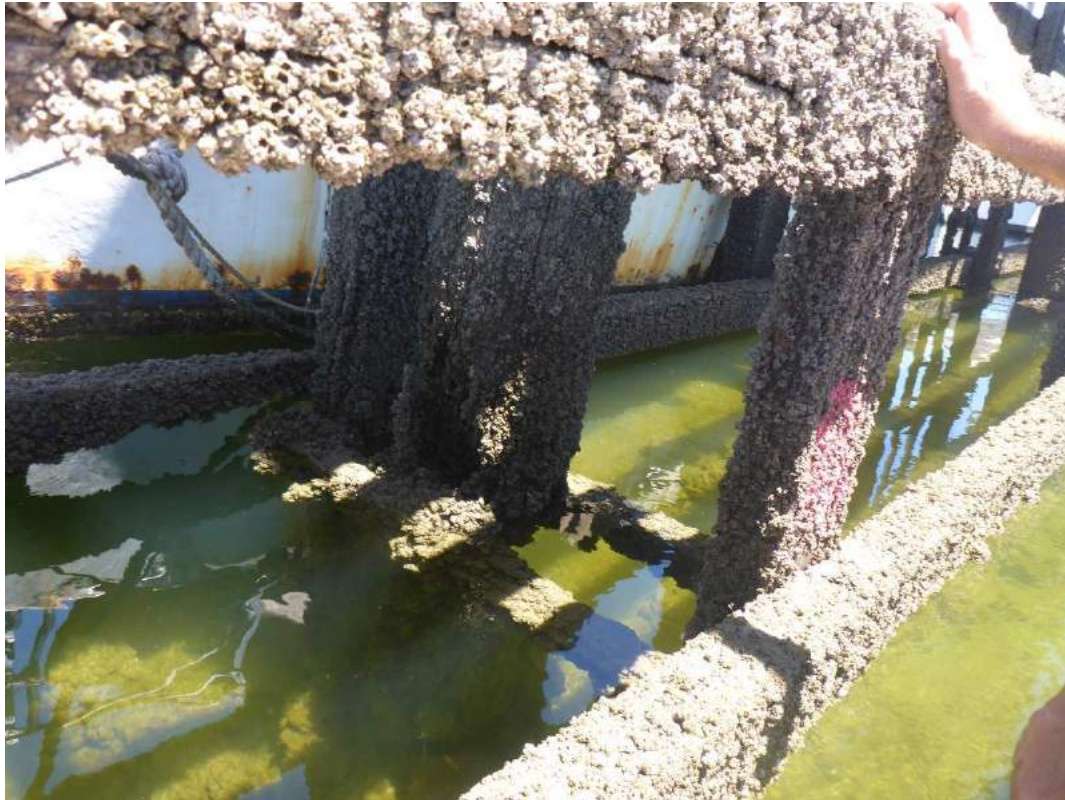
Photo 23 – Badly deteriorated pile but difficult to determine extent of deterioration without underwater assessment

Due to the importance of accurately assessing the reduction in pile size and condition, an underwater assessment of all timber piles along the jetty should be carried out as soon as possible.

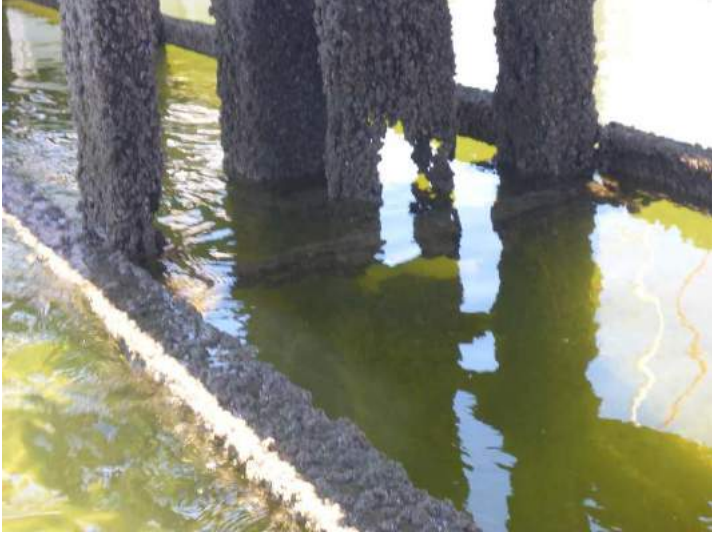
Photo 21 - Bent 19 deteriorated timber pile replaced with steel pile

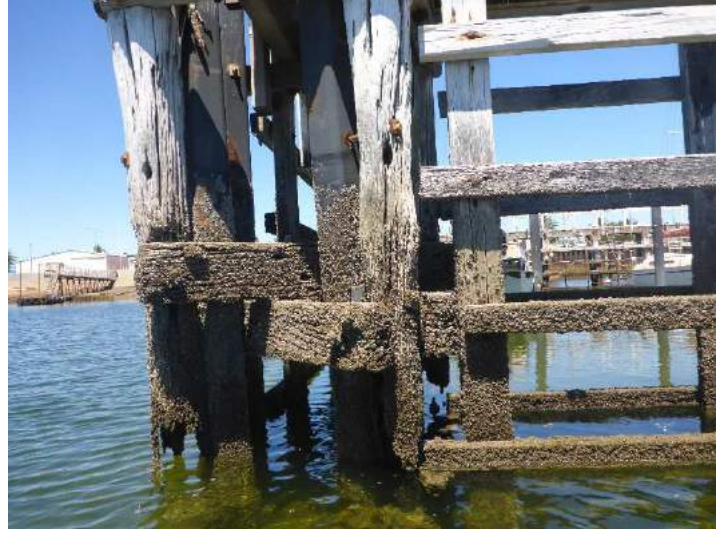
Photo 22 – Bent 21, end of main walkway replaced with 2 steel piles

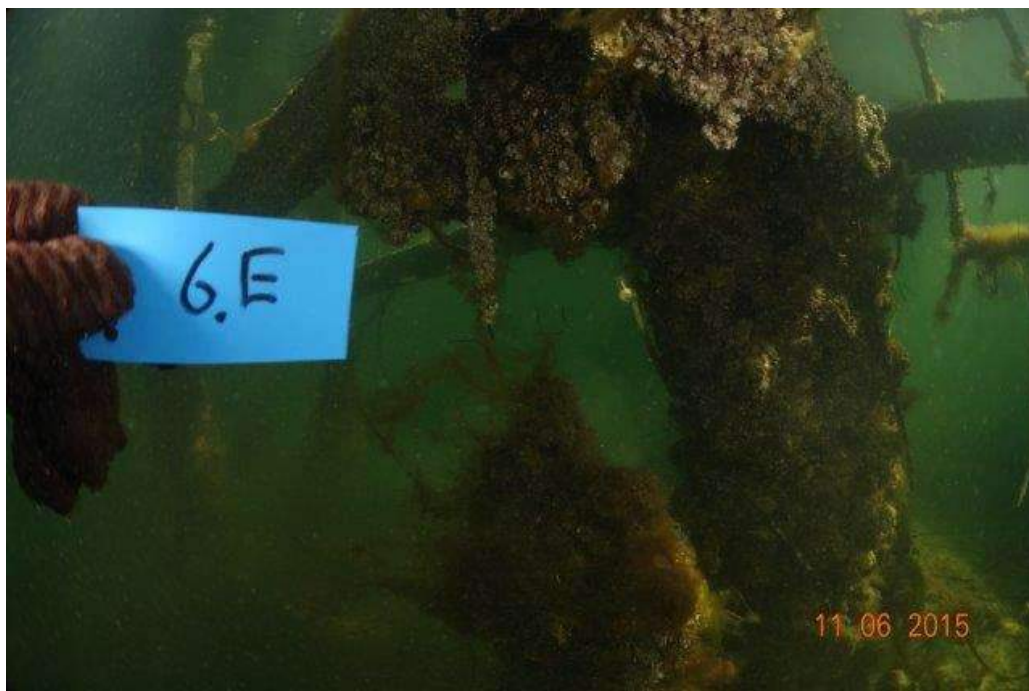
Photo illustrates broken vertical rectangular timber fender adjacent to pile 6 on the eastern side

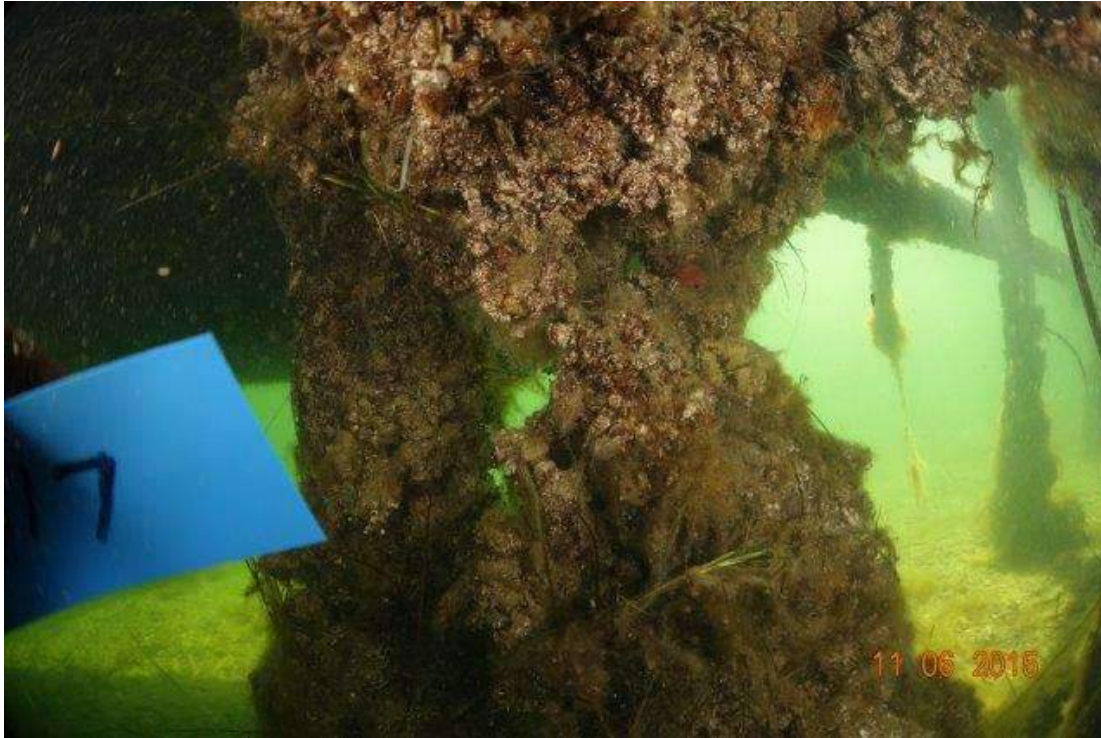
Photo illustrates pile at bent 17 fully deteriorated

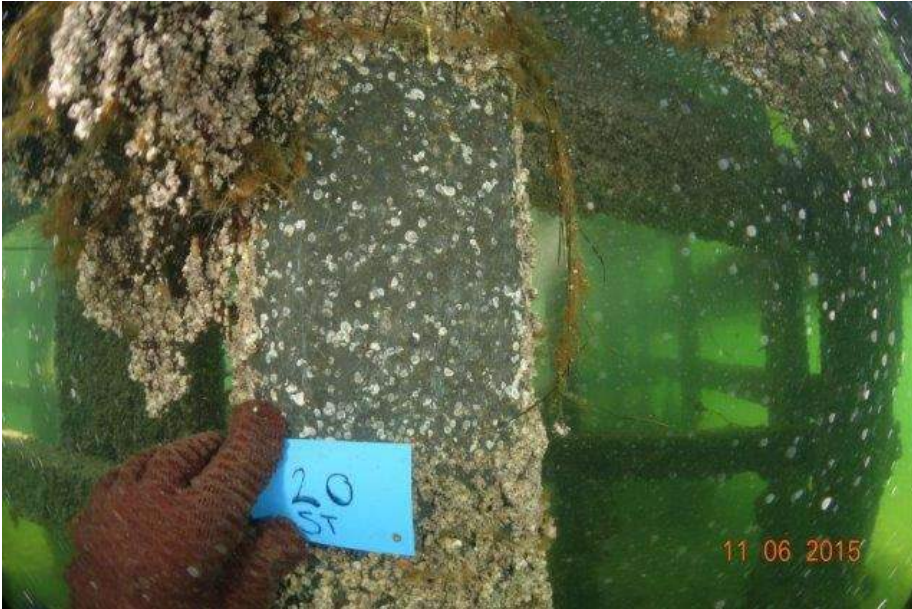
Typical condition of steel pile where cleaned of marine growth (paintwork intact, no signs of corrosion)

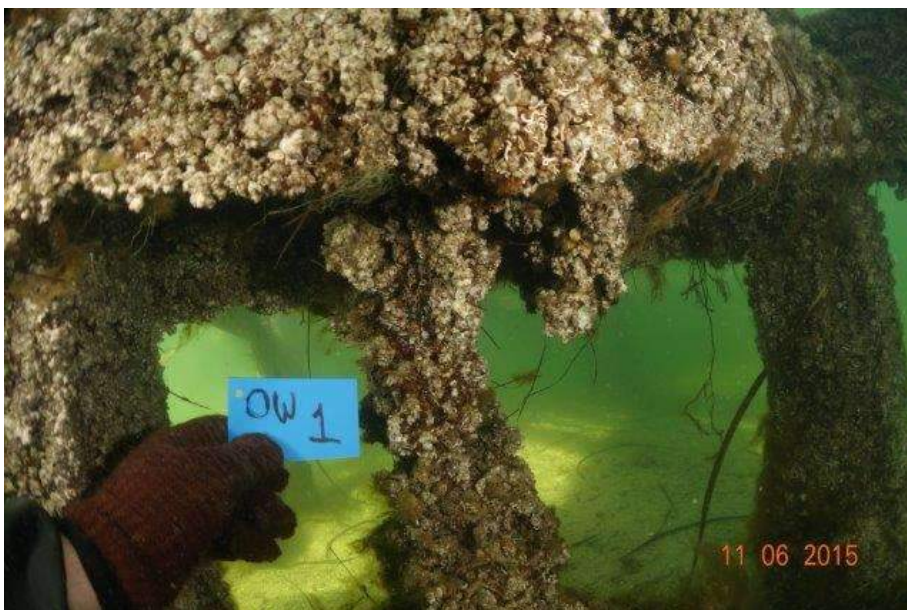
Photo illustrates pile at bent 1 on the outer walkway in poor condition

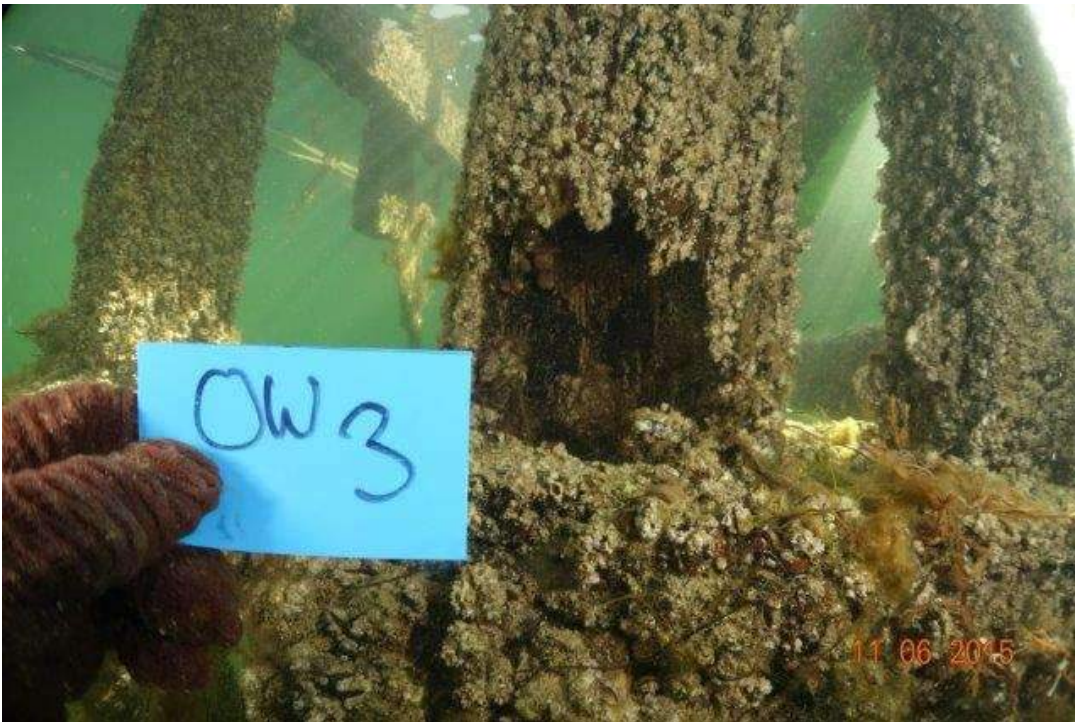
Illustrating defect at at outer walkway bent 3

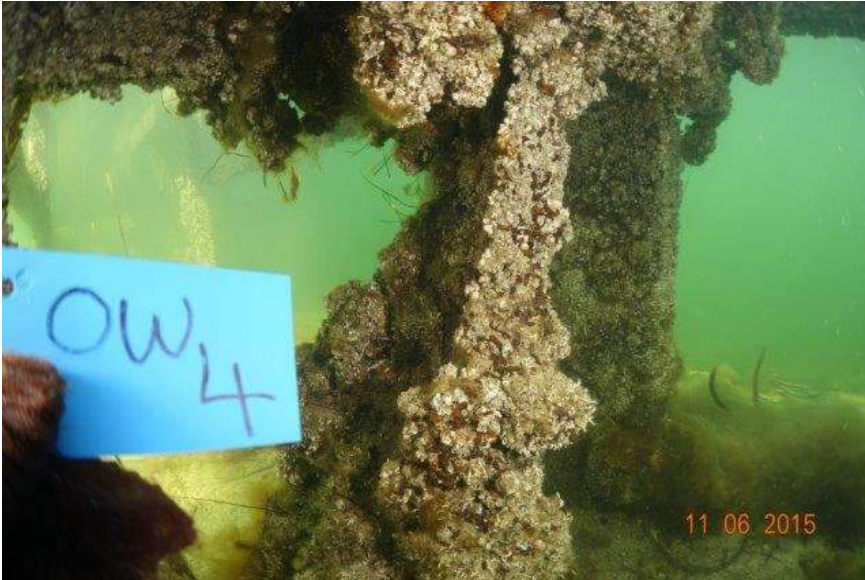
Illustrating defect at outer walkway bent 4 pile

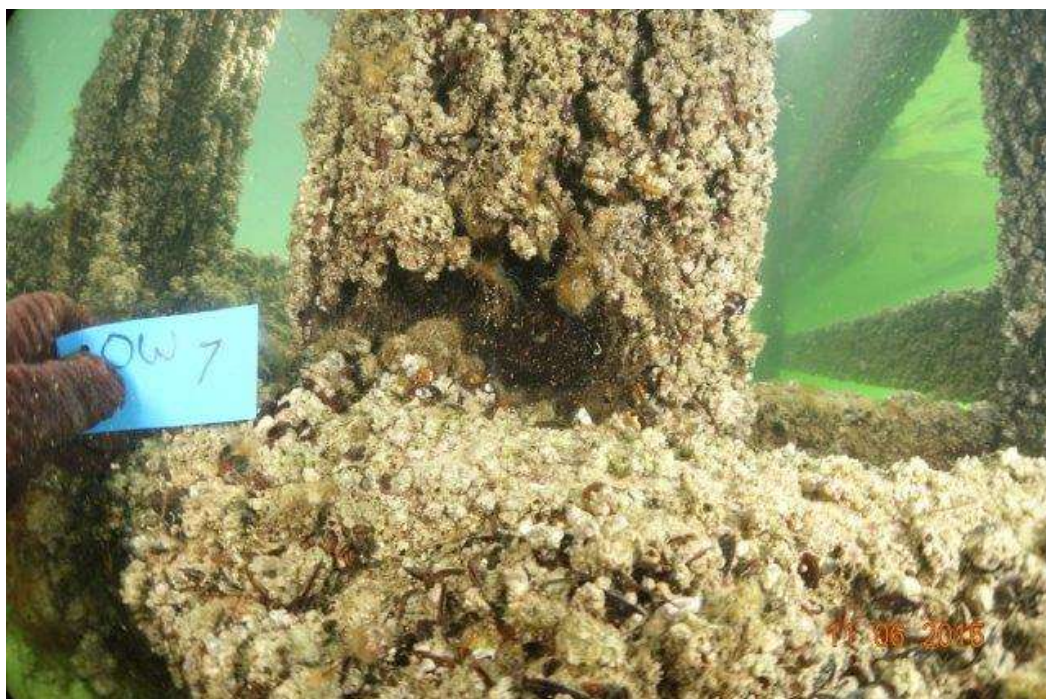
Bent 7 outer walkway pile defect at the crosshead

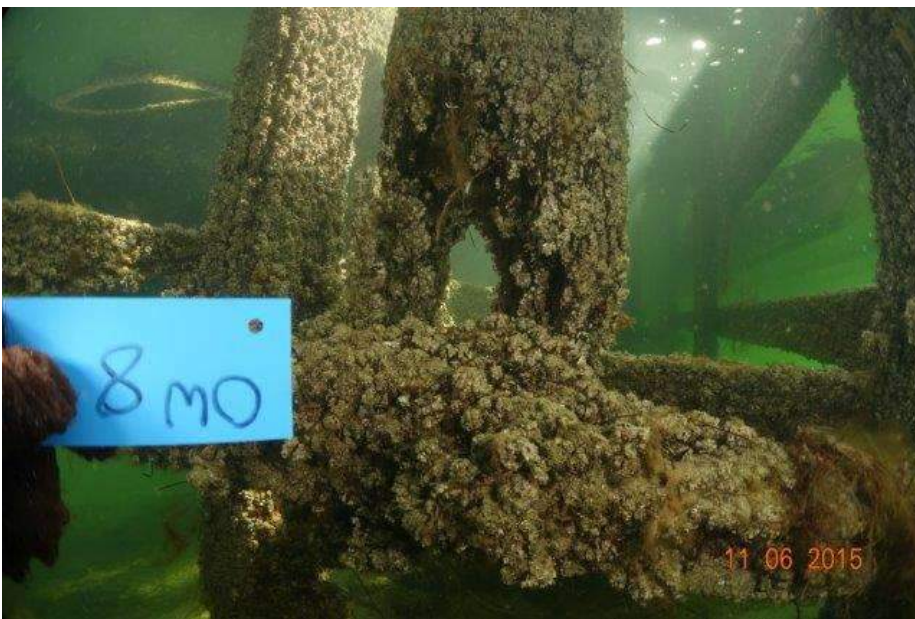
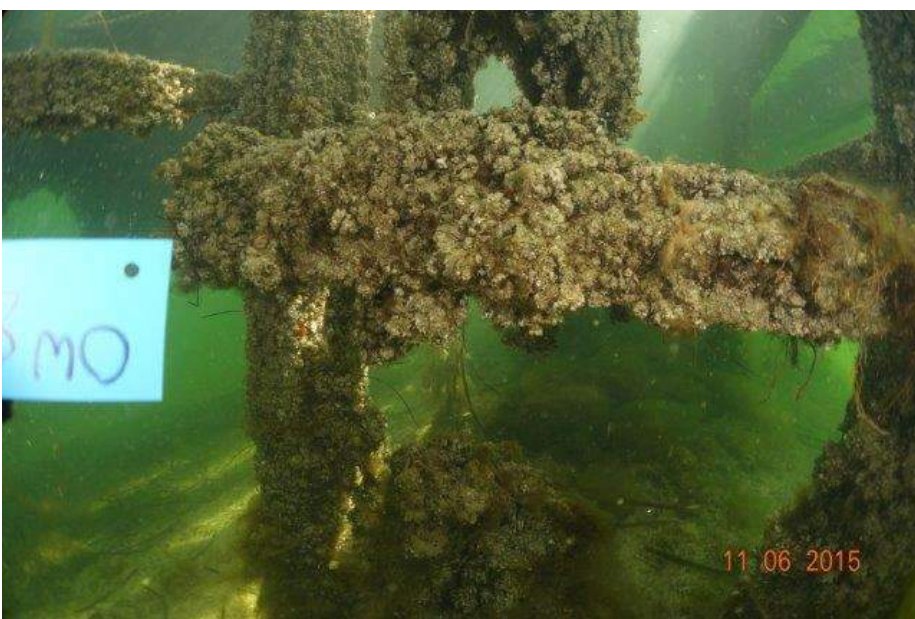
Outer walkway bent 8 illustrating fully broken pile

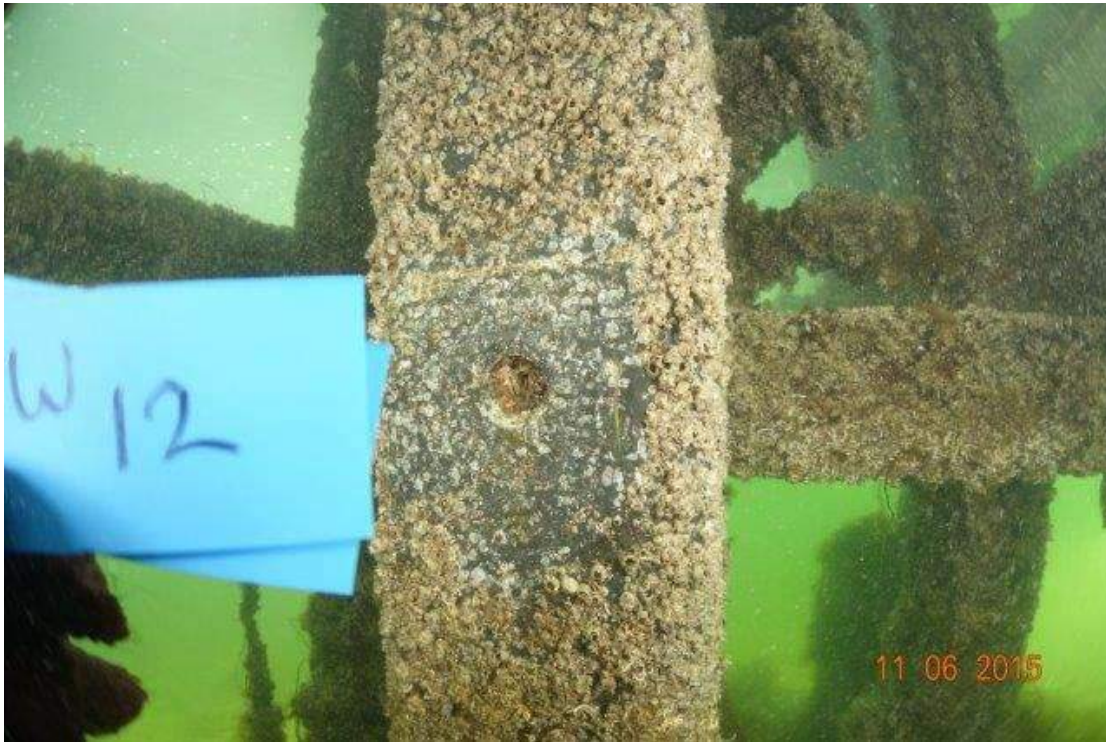
No bolt fitted at pile 12
