Fisherman's Jetty

PORT PIRIE

STUDY REPORT

27 APRIL 2023

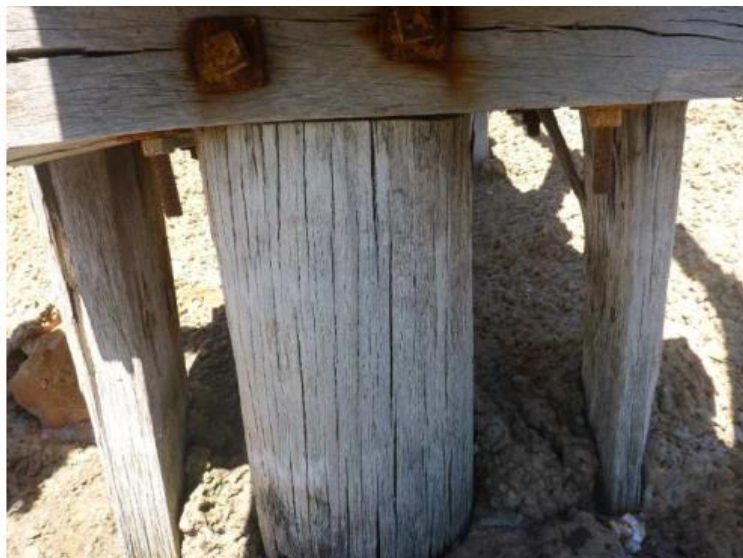
Figure 1: Photo extracted from MACE report – Note MACE Caption

Figure 1 or Photo 19 below is extracted from the MACE report. The items identified as 'rectangular piles' are considered almost certainly fender piles, which are typically driven into the surficial bed only and provide no vertical or lateral support to the structure.

Photo 19 – Typical main set of pile layout with a central circular pile and two rectangular piles

The MACE report appears to have accounted for the fender piles as vertically and laterally supporting the primary structure. Whilst these piles may physically provide some restraint, this is not the design intent and any load paths carried by the fender piles are secondary in nature. The use of secondary load paths to support a structure is not recommended as they are not designed and detailed for the purpose and can result in unexpected and unusual failure mechanism.

On this basis, it is considered likely that the urgency of replacement of some central piles was understated in the MACE report.

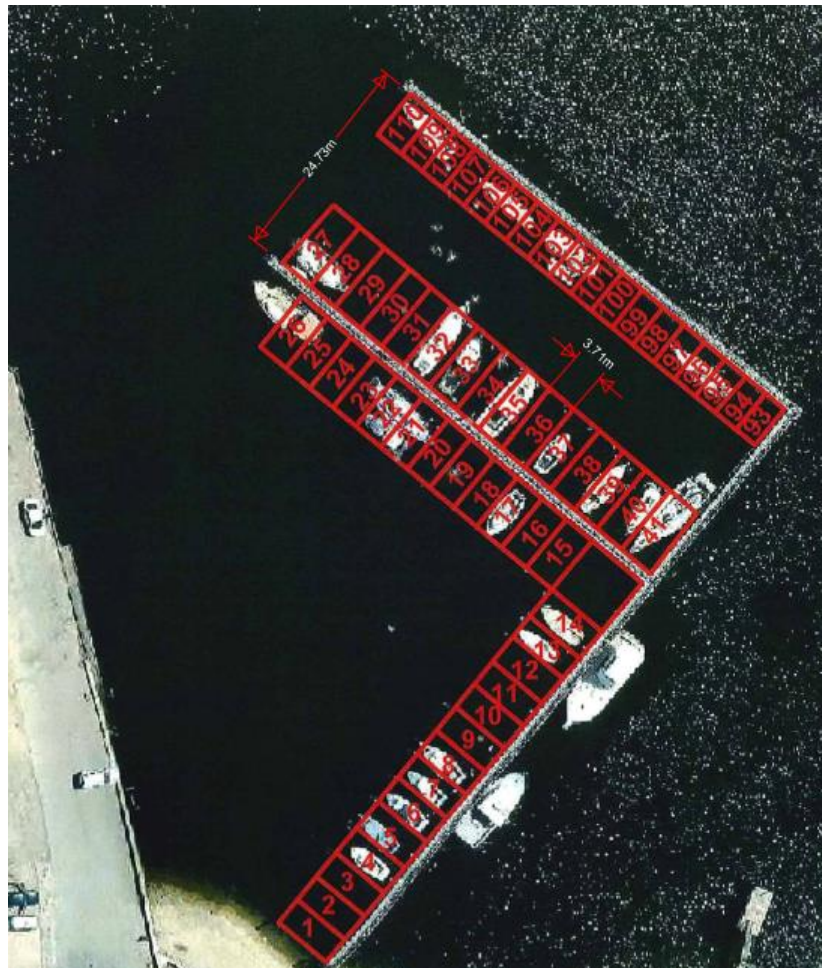
The marina berths are approximately 3.75-4m wide on the main fingers. Approximately 24m total width is provided between the main fingers. This can be seen in Figure 3. Based on the current standard (AS3962), this would limit the size of vessels at the marina as follows:

- Fairway width, 11m. Maximum vessel Length Overall 7.3m
- Berth width 3.75m. Maximum vessel Length 6m, Beam 2.8m

Figure 3: Existing Marina Arrangement, indicating dimension constraints.
