FISHERMAN'S JETTY
STRATEGIC WORKSHOP
9 June 2021

Port Pirie
 Regional Council

ANNEXURE A
Fisherman's Jetty – Locality Plan and Images

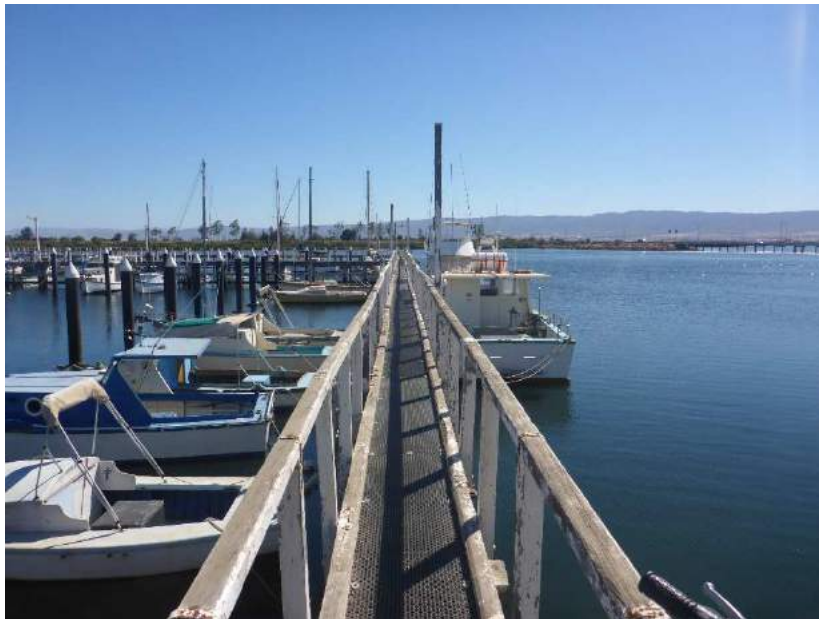
Photo 1 – Fisherman’s Jetty at Port Pirie

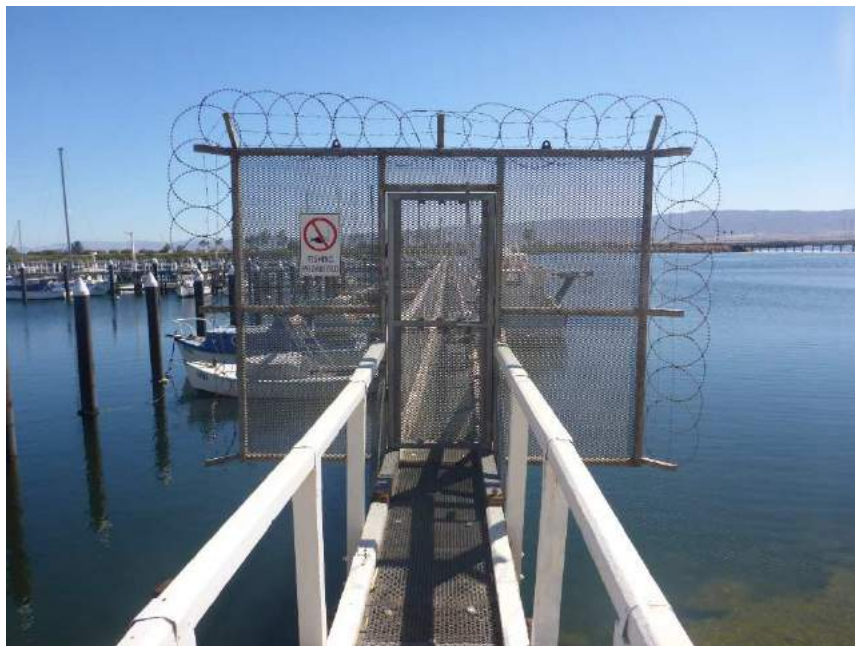
Photo 5 – Typical decking, kickboards and railing with security gate at start of jetty

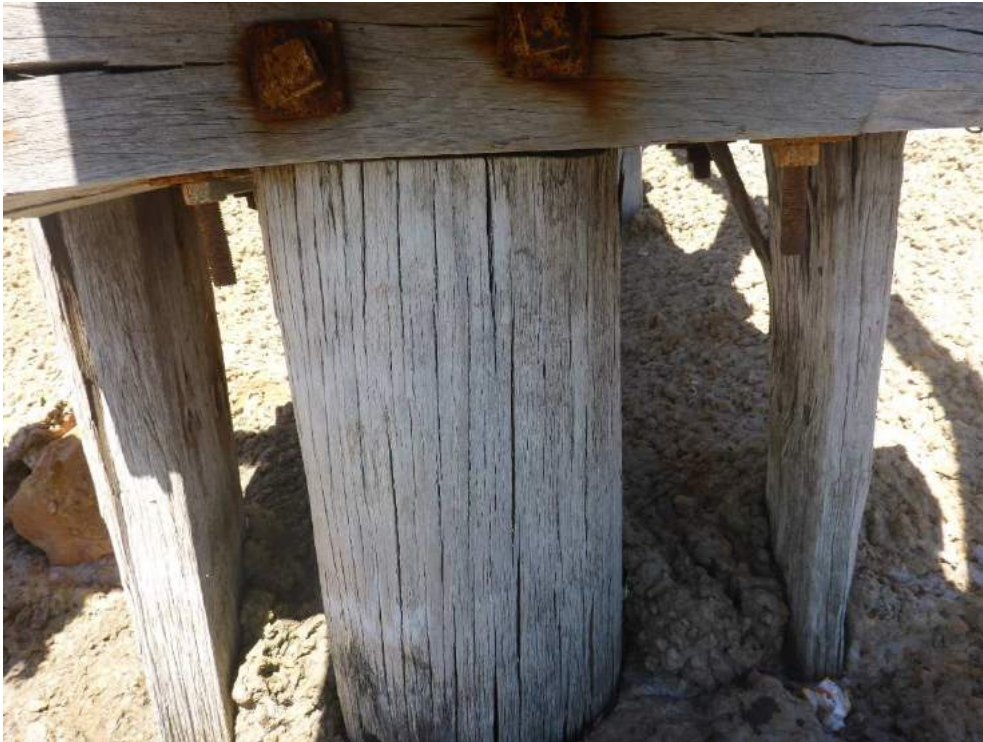
The timber piles comprise of a main set of piles (or bents) at approximately 5.0 metre spacing with intermediate sets of piles at approximately mid span. The main set of piles comprises of a central circular pile varying in diameter from 300 mm to 500 mm. On each side of the circular pile is a rectangular pile 230 mm x 105 mm. Crossheads and girders are then bolted to the main set of piles.

Photo 19 – Typical main set of pile layout with a central circular pile and two rectangular piles

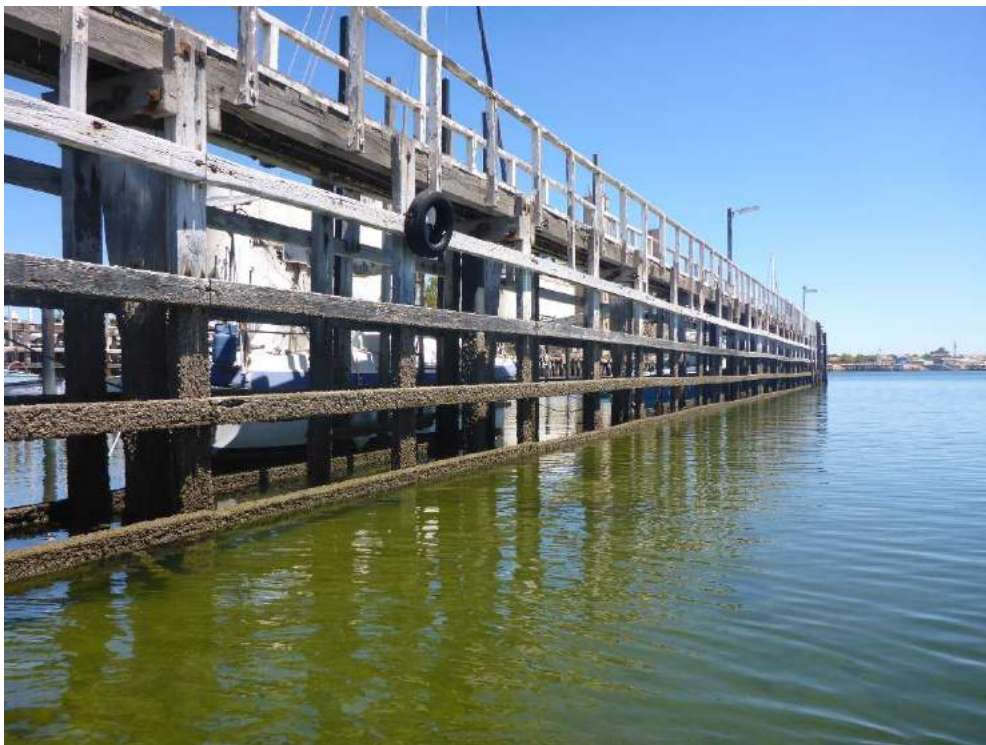
The intermediate sets of piles comprises of two 230 mm x 105 mm rectangular piles bolted to the timber girders.

Photo 20 – Main set of piles with intermediate sets mid span between them

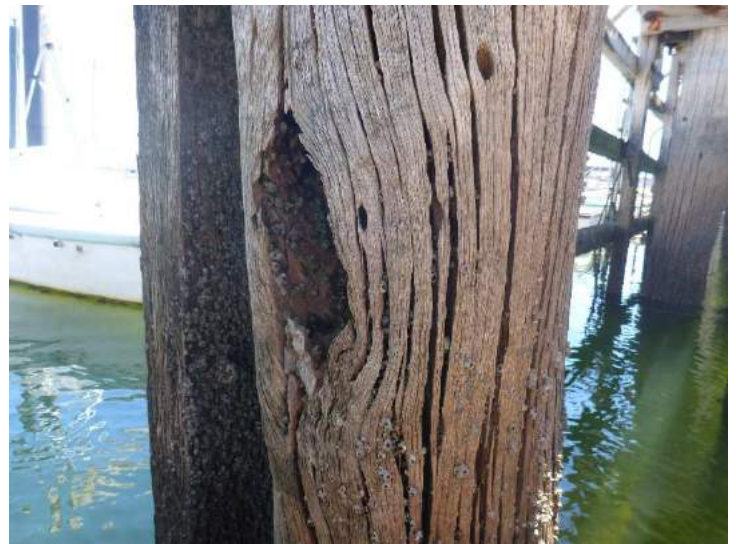
Photo 4 - Bent 3 with only one rectangular pile

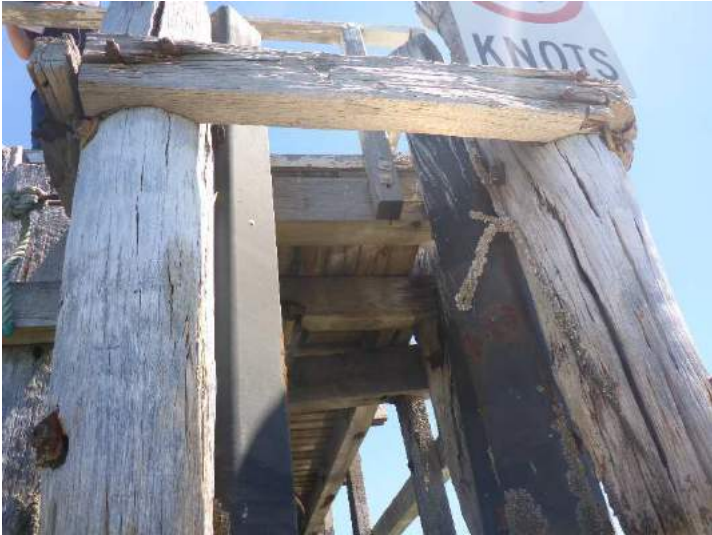
Photo 23 – Bent 21, steel replacement piles

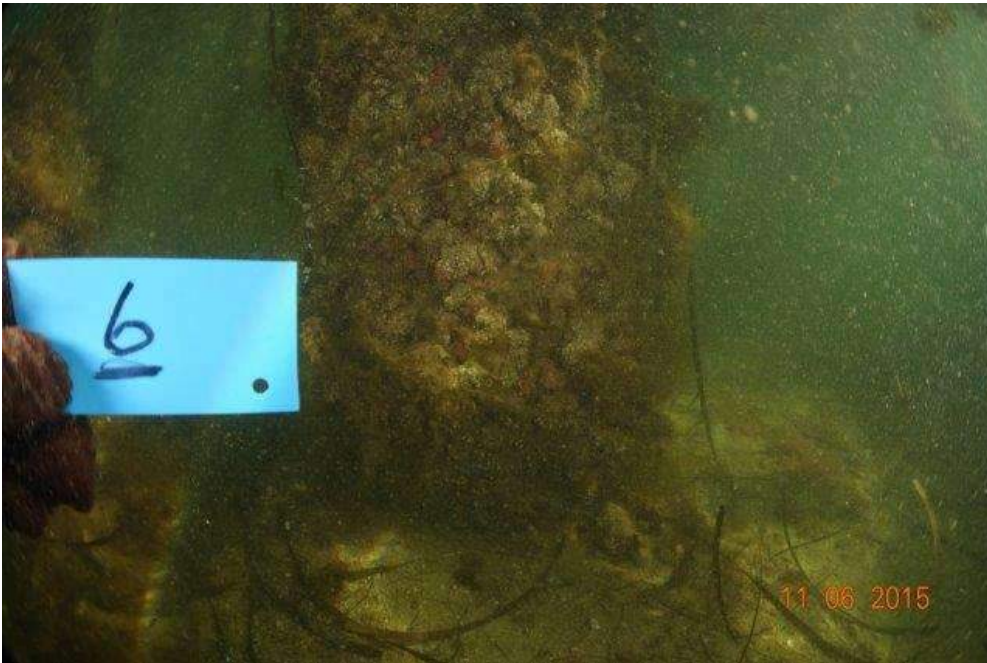
Bent Nos	Pile thickness where pile appeared most deteriorated (mm)	Height above seabed of measured section (mm)	Estimated Percentage of pile deterioration %	Defects (ie splits, holes, necking, fractures, worm activity, scouring structural damage)	Comments
2	460	300	5		No visual defects
3	410	300	5		No visual defects
4	460	300	5		No visual defects
5	460	300	5		No visual defects
6	500	300	5		Broken vertical fender pile on eastern side

Underwater view of pile 6 at seabed (no visual defect)

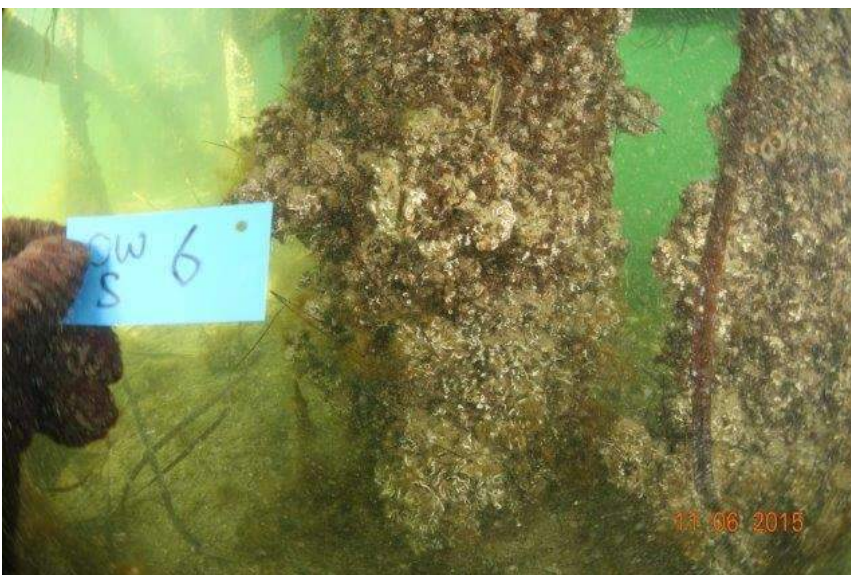
Bent Nos	Pile thickness where pile appeared most deteriorated (mm)	Height above seabed of measured section (mm)	Estimated Percentage of pile deterioration %	Defects (ie splits, holes, necking, fractures, worm activity, scouring structural damage)	Comments
5	400	1 metre	minimal		No visual defects
6 north	270	1 metre	15		
6 south	290	1 metre	20

Pile condition at bent 6 south, outer walkway

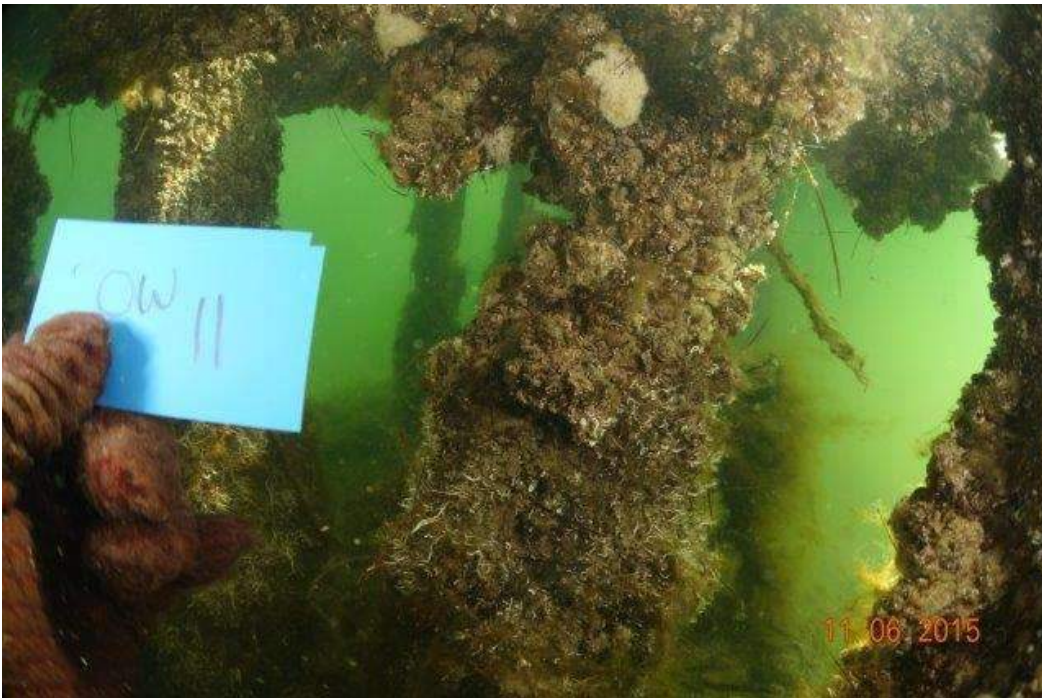
Bent Nos	Pile thickness where pile appeared most deteriorated (mm)	Height above seabed of measured section (mm)	Estimated Percentage of pile deterioration %	Defects (ie splits, holes, necking, fractures, worm activity, scouring structural damage)	Comments
11	120	1 metre	70

Outer walkway bent 11 pile
